DEPARTMENT OF TRANSPORTATION**DIVISION OF ENGINEERING SERVICES**

Quality Assurance and Source Inspection

Contract #: 04-0120F4Cty: SF/ALA Rte: 80 PM: 13.2/13.9File #: 69.28**WELDING INSPECTION REPORT****Resident Engineer:**Pursell, Gary**Address:** 333 Burma Road**City:** Oakland, CA 94607**Report No:** WIR-002709**Date Inspected:** 26-May-2008**Project Name:** SAS Superstructure**OSM Arrival Time:** 630**Prime Contractor:** American Bridge/Fluor Enterprises, a JV**OSM Departure Time:** 1530**Contractor:** Zhenhua Port Machinery Company, Ltd (ZPMC), Changxing Island **Location:** Shanghai, China**CWI Name:** Li Zhijiang and Hu Wei Qing**CWI Present:** Yes No**Inspected CWI report:** Yes No N/A**Rod Oven in Use:** Yes No N/A**Electrode to specification:** Yes No N/A**Weld Procedures Followed:** Yes No N/A**Qualified Welders:** Yes No N/A**Verified Joint Fit-up:** Yes No N/A**Approved Drawings:** Yes No N/A**Approved WPS:** Yes No N/A**Delayed / Cancelled:** Yes No N/A**Bridge No:** 34-0006**Component:** OBG and SAS Tower Fabrication**Summary of Items Observed:**

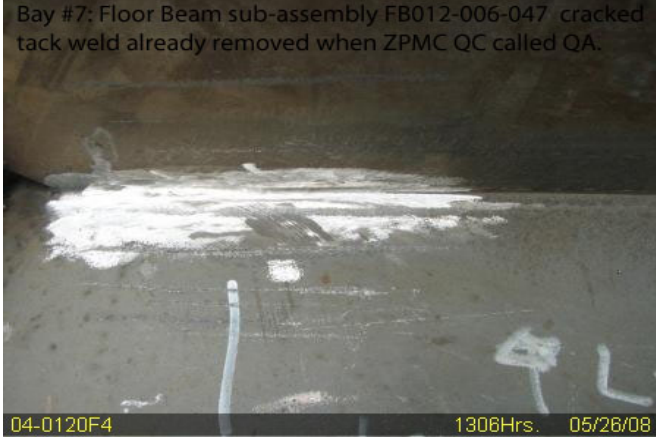
On separate location, one tack weld was noted with crack by ZPMC QC. This QC called the attention of QA J. Lizardo to witness the removal of the crack. Upon arrival at the scene, this QA observed the tack weld was already been ground removed. Then the QC told this QA to witness the MT on the removal but the time would be 1500hr, which already beyond work time duty. Due to time constraint, QA J lizaro turned this over to task leader Jim Cochran.

Bay #7: Floor Beam sub-assembly FB012-006-047 cracked tack weld already removed when ZPMC QC called QA.

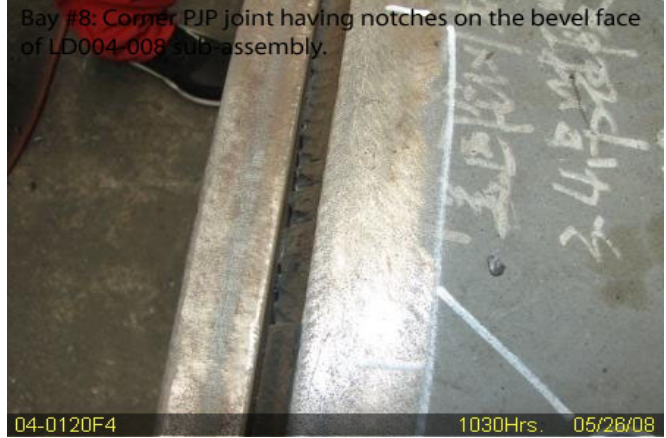
Bay #8: Corner PJP joint having notches on the bevel face of LD004-008 sub-assembly.
